# Manhole Inspection Summary

Manhole # S41K\_\_039MH

**Location** Address: **901 eastern av**

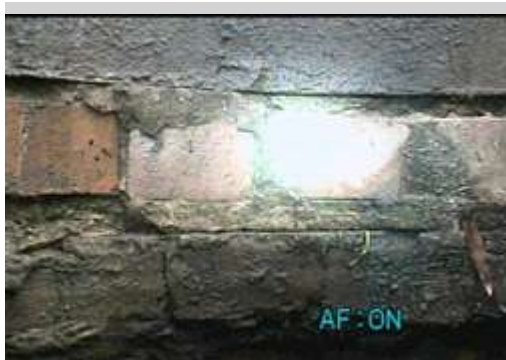
Defect 2

Condition: ☐ Sound ☐ Cracked ☐ Root Intrusion ☐ Loose Brick ☒ **Deteriorated**

chimney deteriorated at frame joint

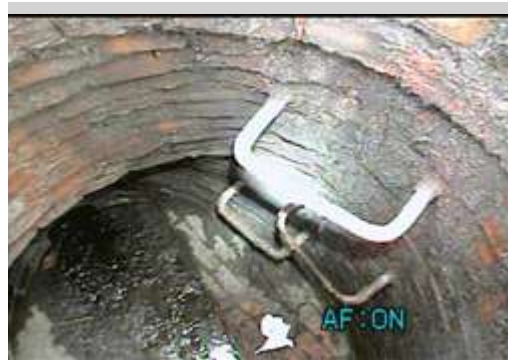
Defect 1

Infiltration: ☐ None ☐ Joint ☐ Cracks ☐ Mortar ☐ Roots ☒ **Wall**

Count: **3** Missing: **0** ☒ **Corroded**

steps corroded, signs of infiltration on corbal wall
